**State of Louisiana
Department of Natural Resources
Coastal Engineering Division**

**2006/2007 Annual Inspection
Report**

**OAKS/AVERY CANALS
HYDROLOGIC RESTORATION
PROJECT**

State Project Number TV-13a
Priority Project List 6

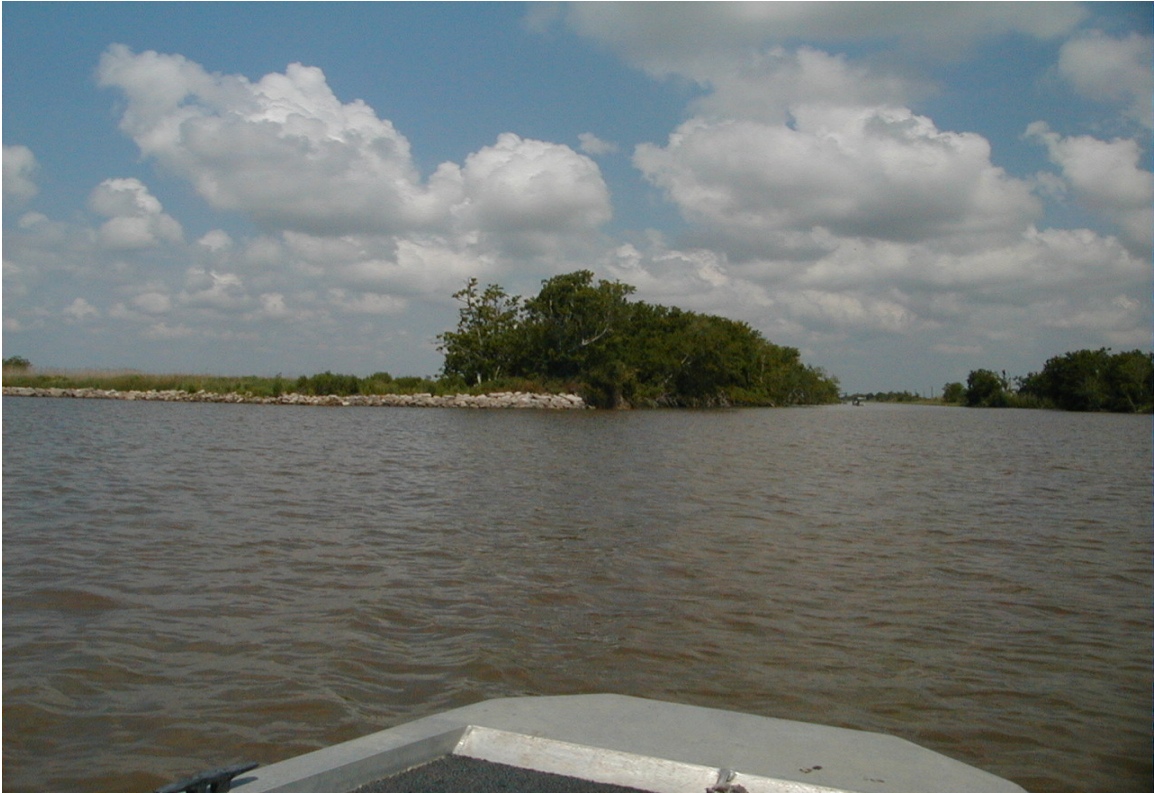
The dike is in excellent condition.. Approximately 60 linear feet on the eastern end at a barge slip continues to settle but is and in no need of any repairs. East and west tie-ins are stable. (Appendix B; photos 1-3)

Photo 1— rock dike on north bank of GIWW; east tie in

Item	Condition	Physical Damage	Corrosion	Photo #	Observations and Remarks
Steel Bulkhead / Caps	N/A				
Steel Grating	N/A				
Stop Logs	N/A				
Hardware	N/A				
Timber Piles	N/A				
Timber Wales	N/A				
Galv. Pile Caps	N/A				
Vegetation	N/A				
Signage / Supports	N/A				
Rip Rap/dike	Excellent			1-3	Dike is excellent post construction condition. Approx. 60 LF on eastern end hit by barge continues to settle.
Eathern Embankment	N/A

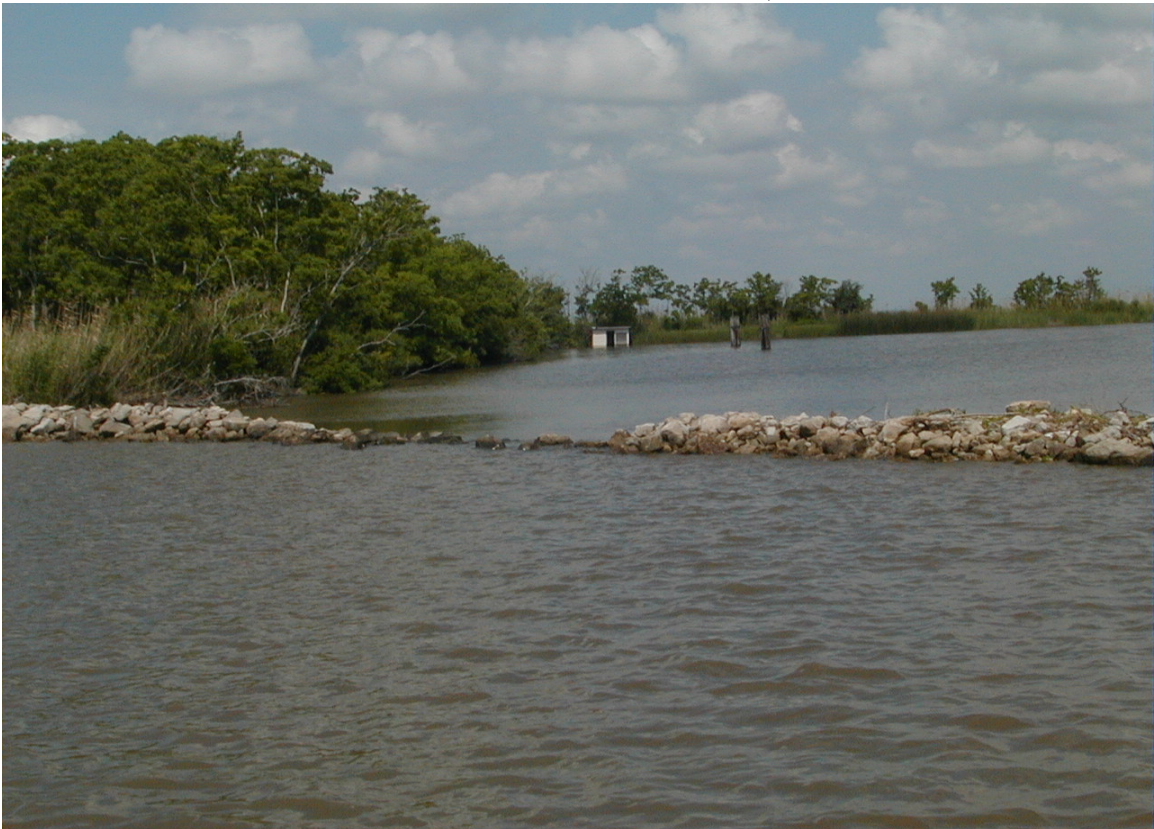
Photo 2—settled rock on north bank of GIWW at barge slip

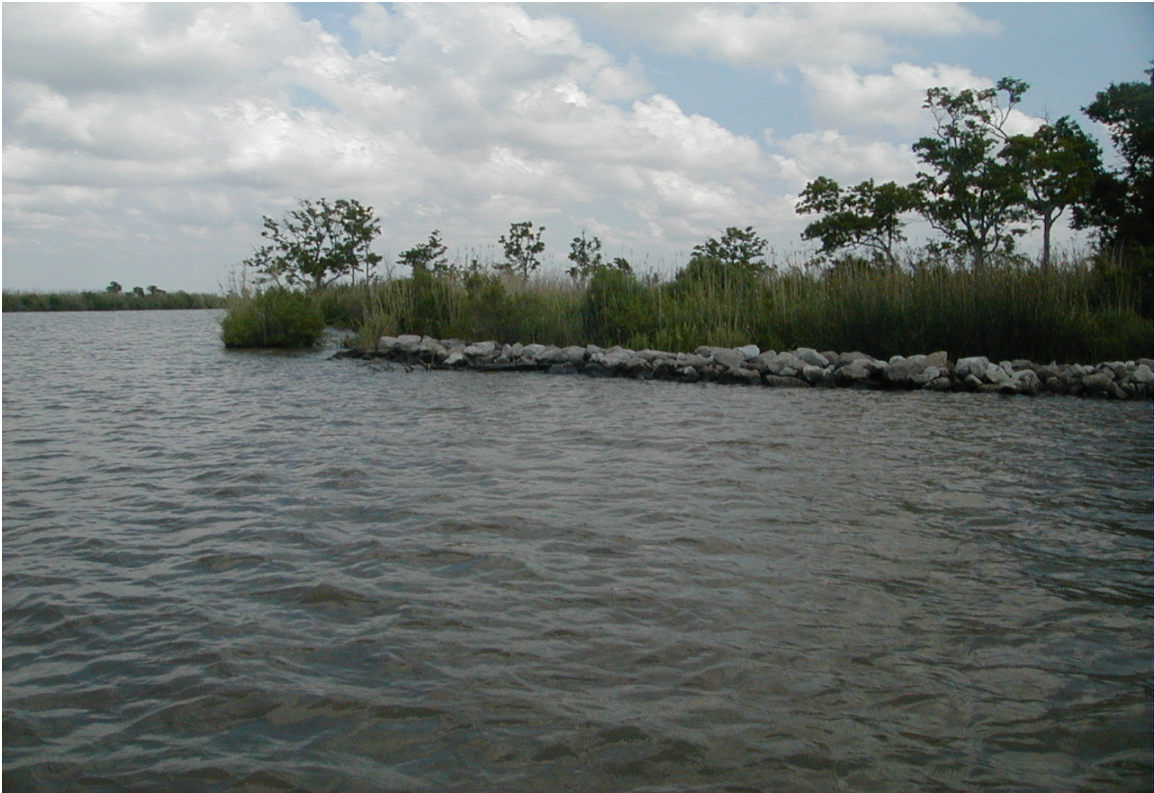
Photo 3-- rock dike on north bank of GIWW; west tie in

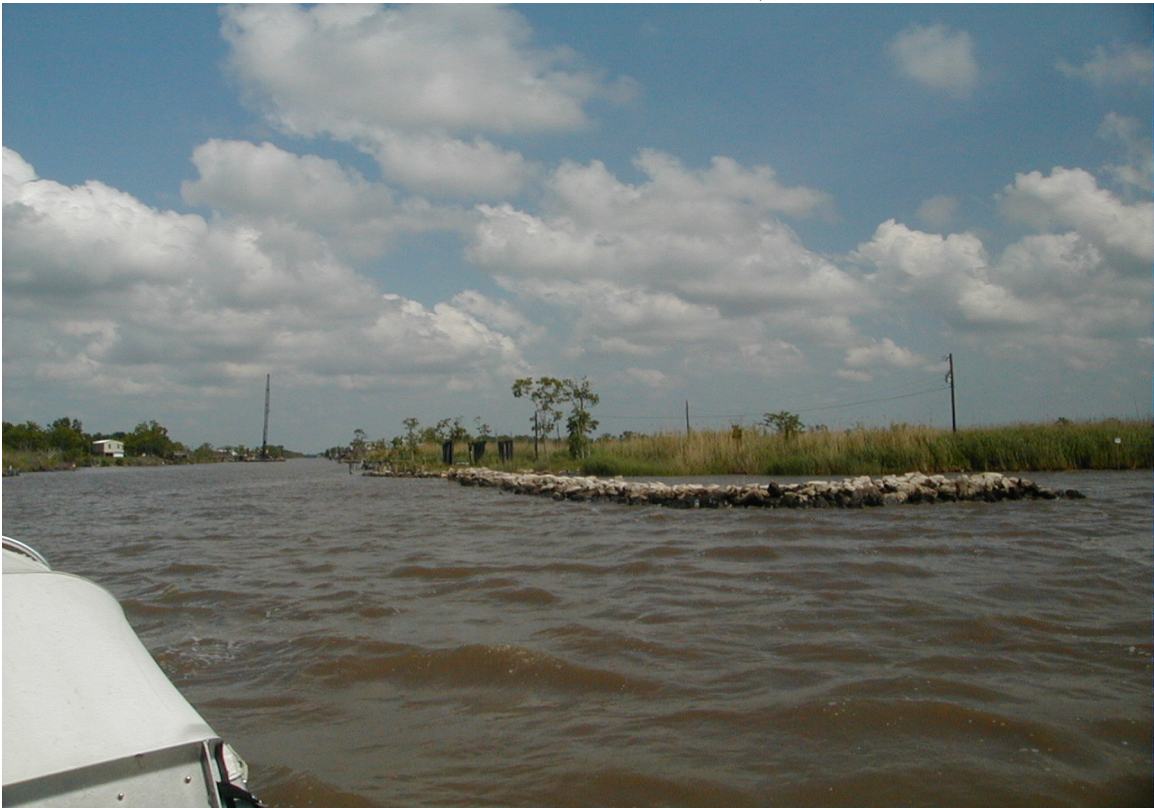
High tides concealed the area along the western bank paving where some rock had apparently slid into the channel. No worsening in this area was evident. The bank between the bay and

Bayou Hebert is still only about 6 feet wide and has not gotten any worse. No immediate maintenance required at this time. (Appendix B; photos 4-5)

Photo 4—east bank of Oaks Canal

Item	Condition	Physical Damage	Corrosion	Photo #	Observations and Remarks
Steel Bulkhead / Caps	N/A				
Steel Grating	N/A				
Stop Logs	N/A				
Hardware	N/A				
Timber Piles	N/A				
Timber Wales	N/A				
Galv. Pile Caps	N/A				
Vegetation	N/A				
Signage / Supports	N/A				
Rip Rap (fill)	Excellent			4 & 5	Rock in excellent condition
Eathern Embankment	N/A

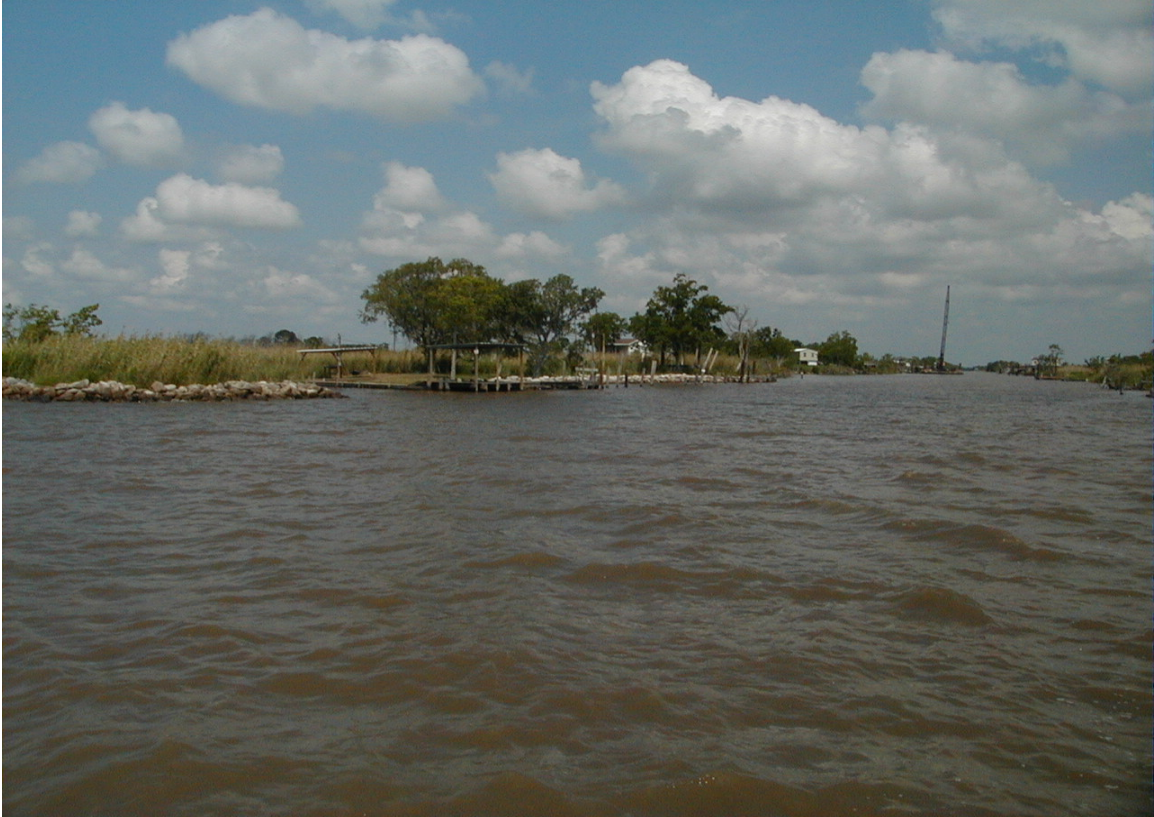
Photo 5—west bank of Oaks Canal

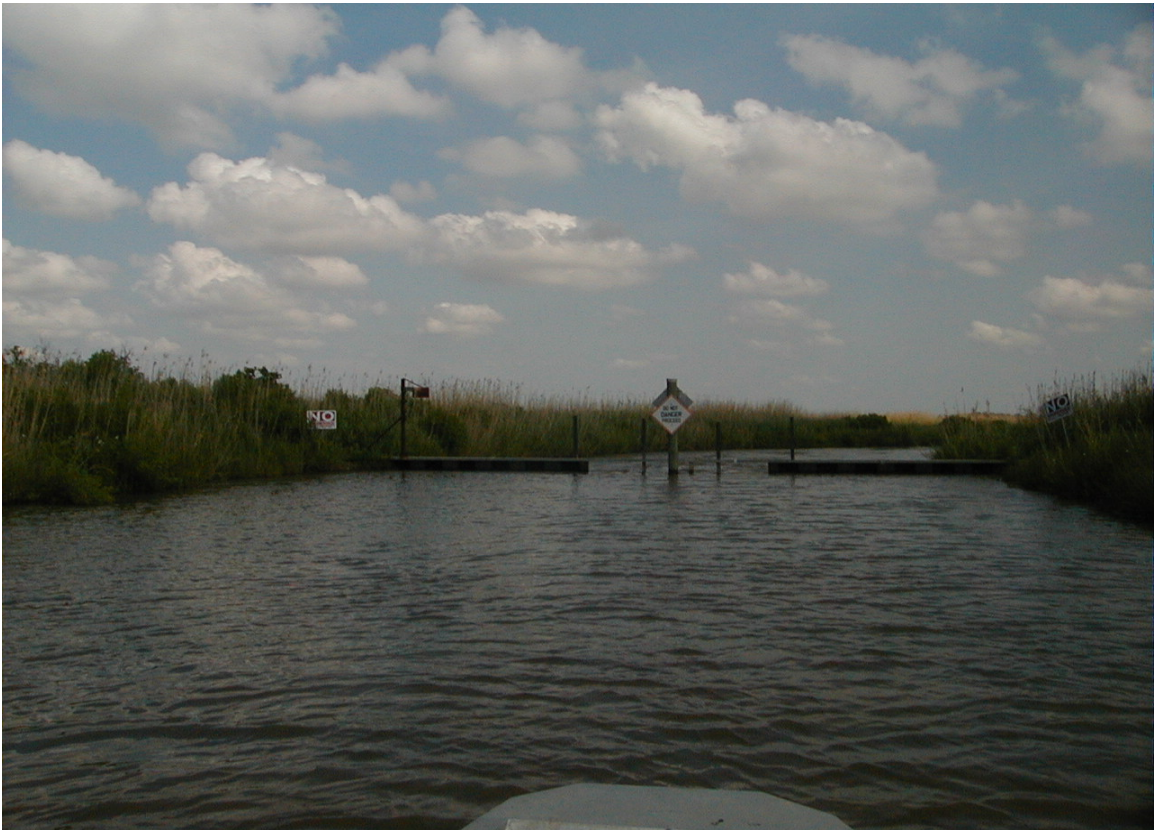
The structure is in excellent shape. Signage is stable. Wingwalls show no signs of any erosion. Three SS bolts are missing from pile cap and will eventually need to be replaced, probably by DNR personnel. The levee from the structure to the GIWW is stable. No maintenance required at this time. Landowners have installed what appears to be a boat lifting device on the western half of the structure, as well as channel iron to accept stoplogs. This will be investigated further by LDNR. (Appendix B; photos 6-9)

Photo 6—cow path structure

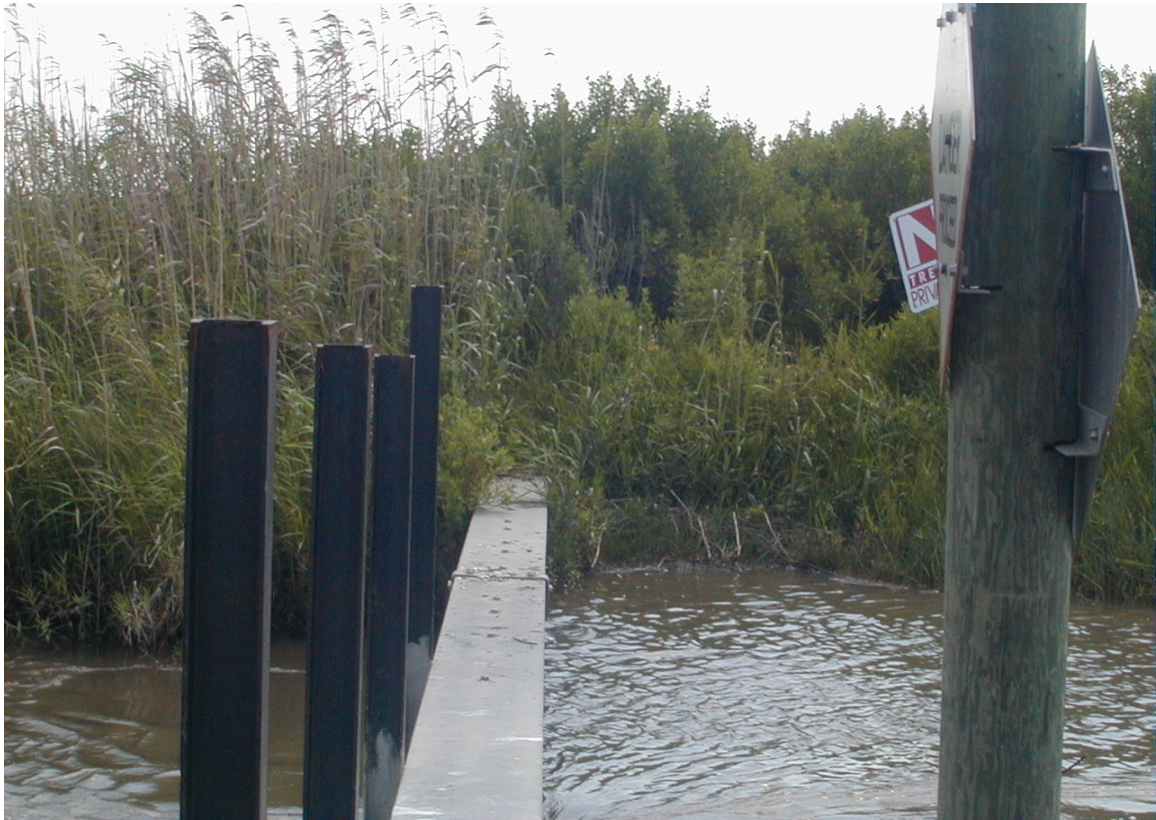
Photo 7—landowner installed channel iron

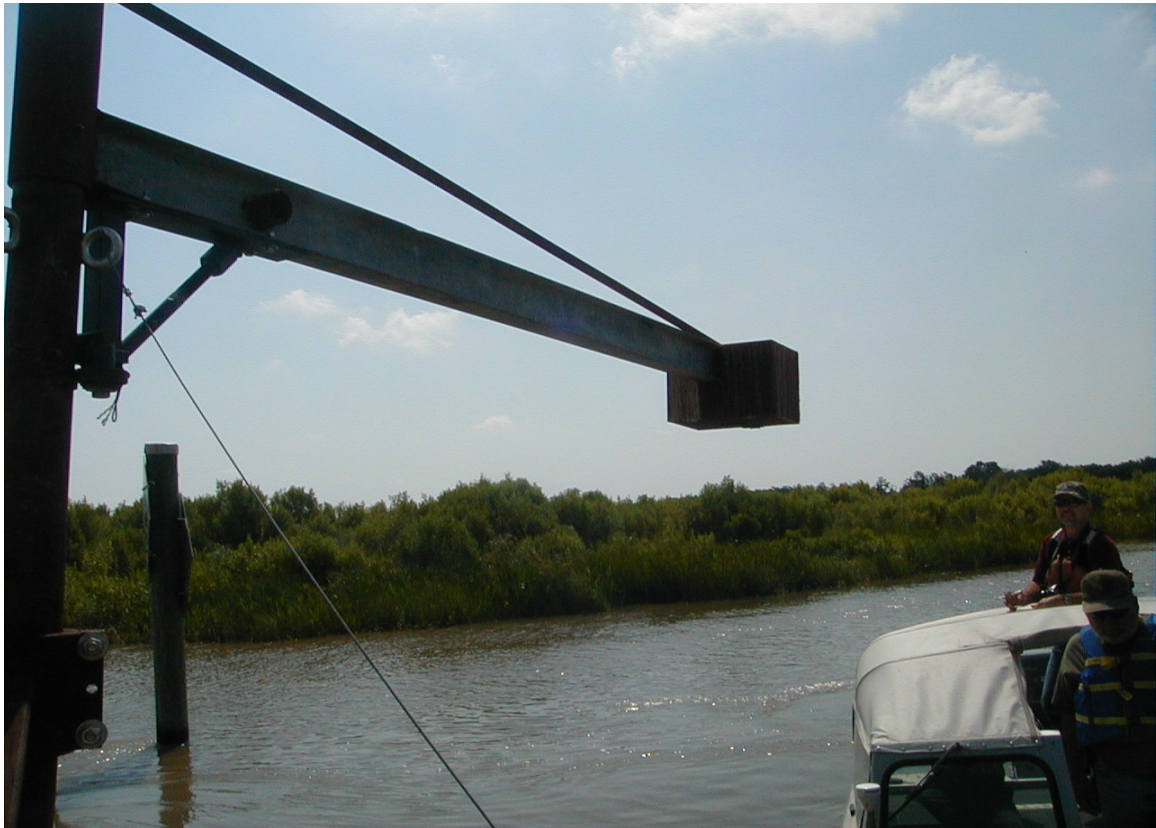
Photo 8—landowner installed boat lifting device

Item	Condition	Physical Damage	Corrosion	Photo #	Observations and Remarks
Steel Bulkhead / Caps	Excellent			7	
Steel Grating	N/A				
Stop Logs	N/A				
Hardware	Good			8 & 9	Three SS bolts missing from pile cap. Not critical. Landowner installed boat lifting device.
Timber Piles	N/A				
Timber Wales	N/A				
Galv. Pile Caps	Excellent			9	
Vegetation	N/A				
Signage / Supports	Excellent			6	
Rip Rap (fill)	N/A				
Eathem Embankment	Excellent

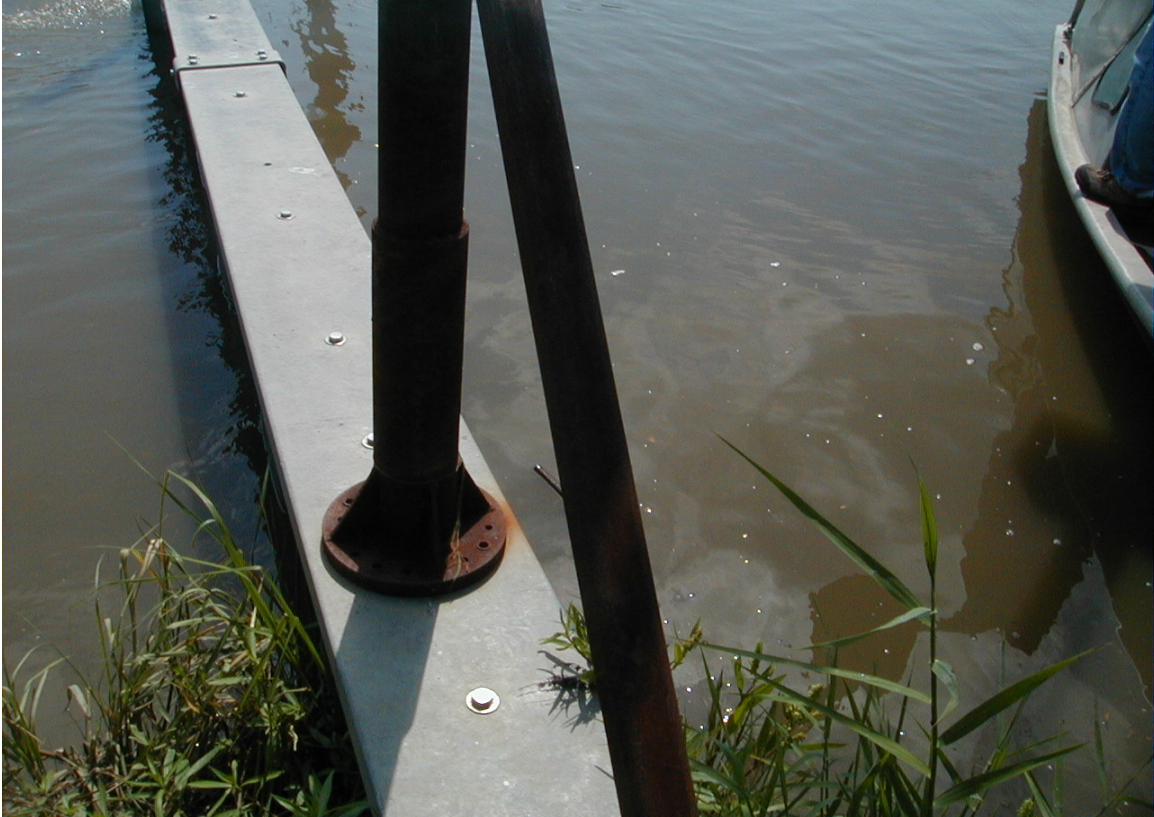
Photo 9—boat lifting device mounted to pile cap

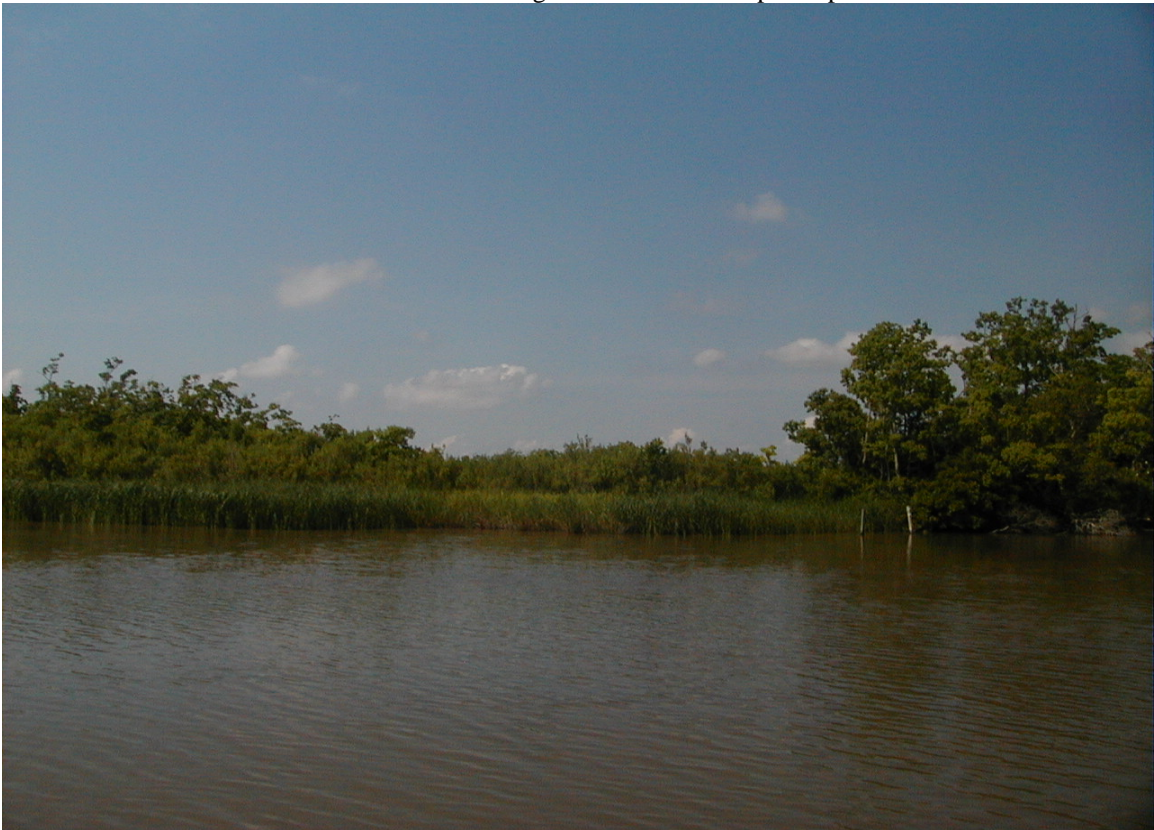
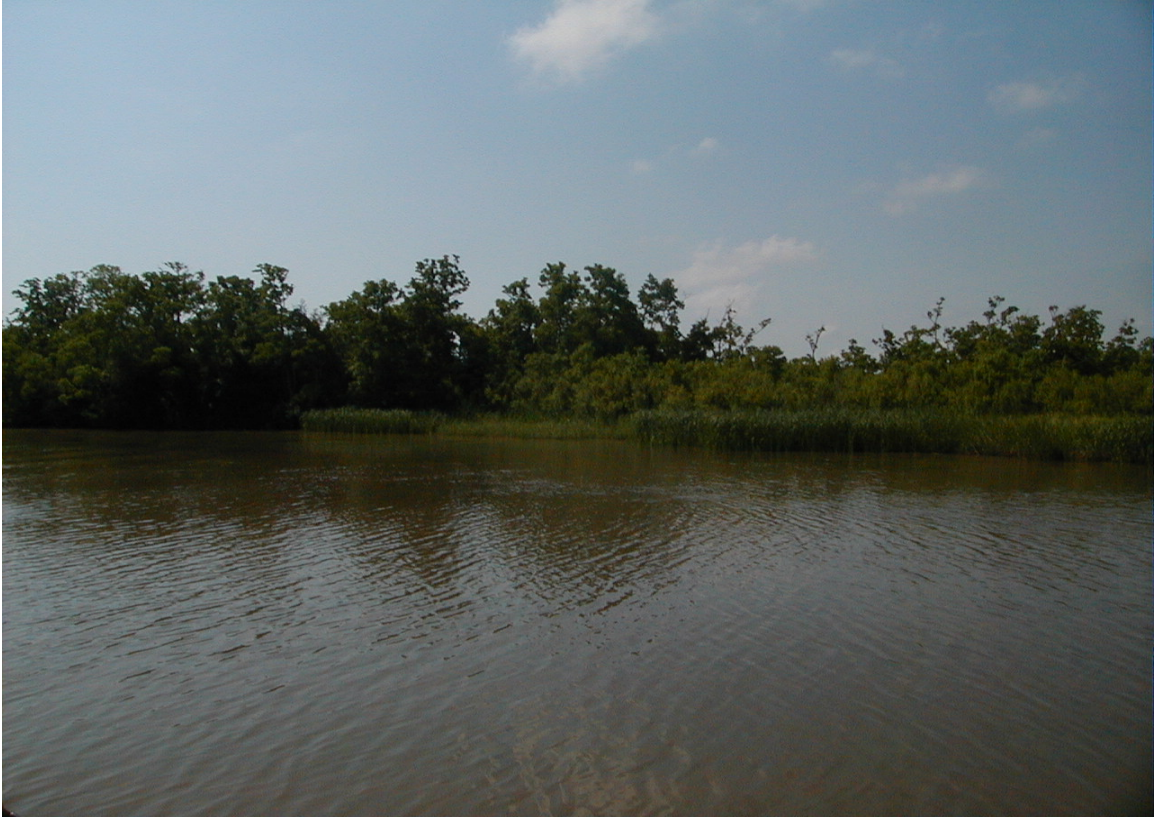
The closures are holding up well. Vegetation has been established. No need for any repairs. (Appendix B; photos 10-11)

Photo 10—earthen levee

Photo 11—earthen levee

Item	Condition	Physical Damage	Corrosion	Photo #	Observations and Remarks
Steel Bulkhead / Caps	N/A				
Steel Grating	N/A				
Stop Logs	N/A				
Hardware	N/A				
Timber Piles	N/A				
Timber Wales	N/A				
Galv. Pile Caps	N/A				
Vegetation	N/A				
Signage / Supports	N/A				
Rip Rap (fill)	N/A				
Earth Embankment	Excellent			10-11

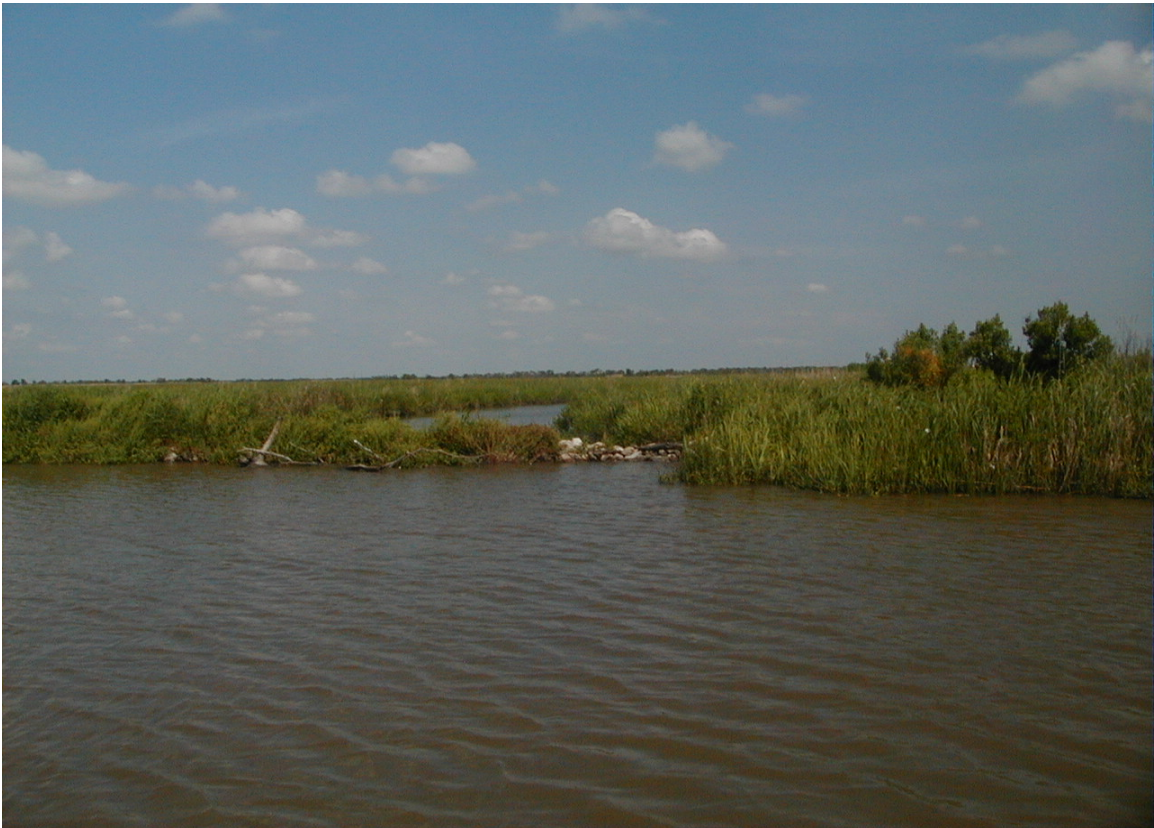
The plug is in excellent condition. No evidence of settling or vandalism. Tie-ins are stable. No need for any repairs. (Appendix B; photo 12)

Photo 12—rock plug

Item	Condition	Physical Damage	Corrosion	Photo #	
Steel Bulkhead / Caps	N/A				
Steel Grating	N/A				
Stop Logs	N/A				
Hardware	N/A				
Timber Piles	N/A				
Timber Wales	N/A				
Galv. Pile Caps	N/A				
Vegetation	N/A				
Signage / Supports	N/A				
Rip Rap (fill)	Excellent			12	
Eathem Embankment	N/A

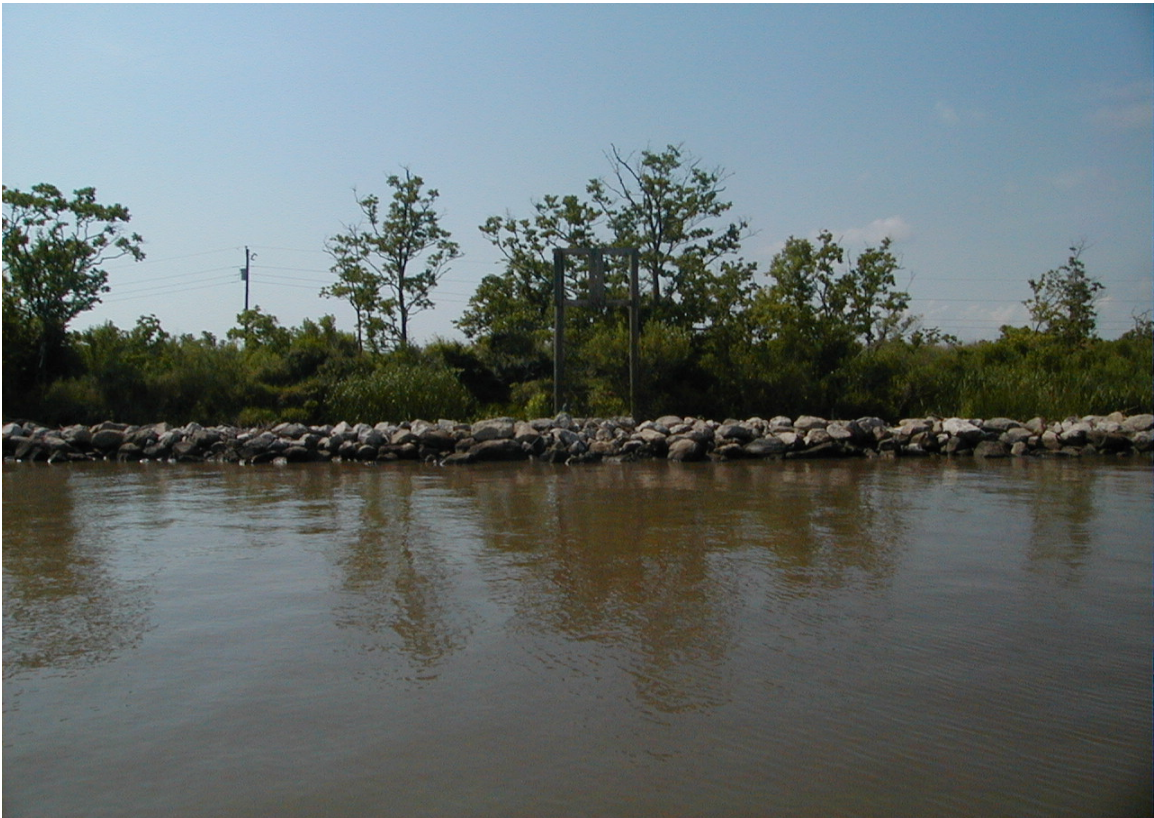
The dike is in immediate post construction condition and in no need of any repairs. (Appendix B; photo 13)

Photo 13—typical section of rock dike on south bank of GIWW

Item	Condition	Physical Damage	Corrosion	Photo #	Observations and Remarks
Steel Bulkhead / Caps	N/A				
Steel Grating	N/A				
Stop Logs	N/A				
Hardware	N/A				
Timber Piles	N/A				
Timber Wales	N/A				
Galv. Pile Caps	N/A				
Vegetation	N/A				
Signage / Supports	N/A				
Rip Rap (fill)	Excellent			13	
Eathem Embankment	N/A
